Newfound Lake Watershed Assessment (2011)

Prepared by
University of New Hampshire Center for Freshwater Biology and University of New
Hampshire Cooperative Extension

Craycraft, Robert C. and Jeffrey A. Schloss. Final Report: Newfound Lake Water Quality Assessment. May 2011. UNH Center for Freshwater Biology, UNH Cooperative Extension. University of New Hampshire. Durham, NH. CFB Report # 2011-05-DES-01.

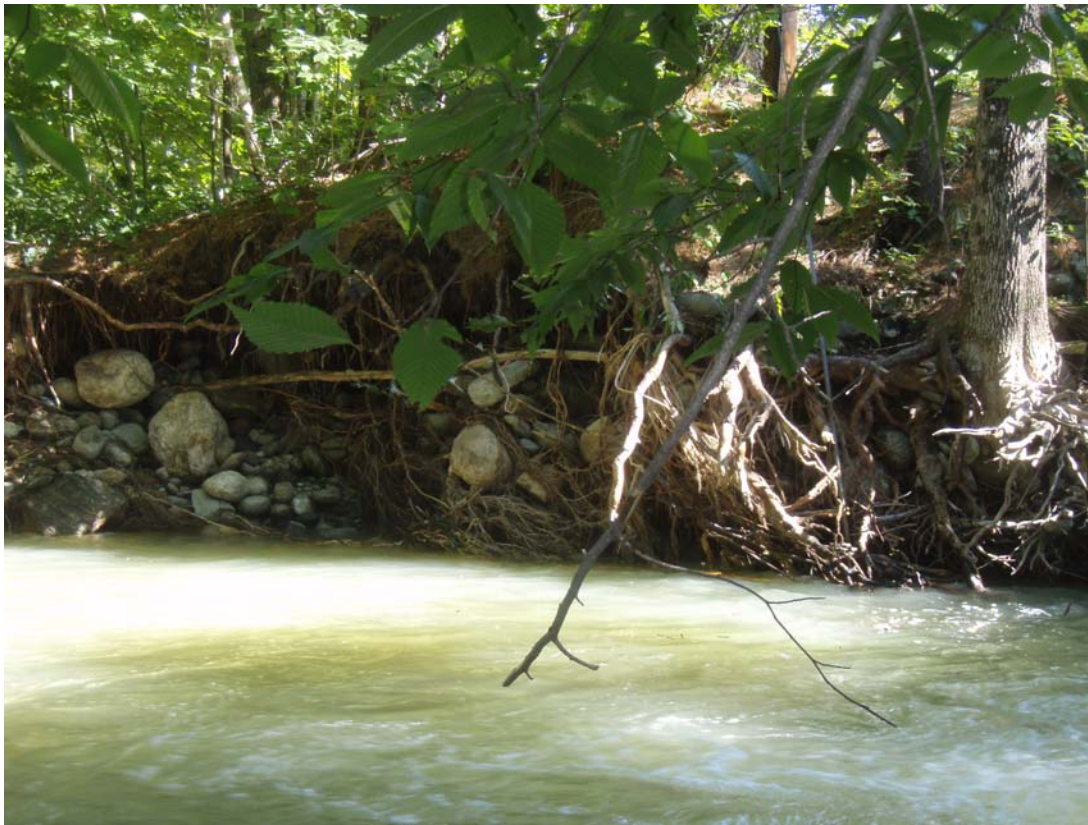
While the Newfound Tributary water quality is generally excellent, water quality sampling during higher flow periods and following heavy periods of rainfall reaffirms the threat of phosphorus and sediment loading from upland sources. Sampling included total phosphorus spikes during a period of elevated spring runoff on May 19 and is a reminder that increased phosphorus load can occur during periods of heavy watershed runoff. Headwater tributary sampling that followed the August 26, 2011 Tropical Storm Irene and a late September/early October period of five days of sustained rainfall documented elevated turbidity levels in both Brock Brook of the Fowler River subwatershed and Atwell Brook of the Cockermouth River subwatershed that suggest elevated sediment loading at those times. A visual examination of both Brock Brook (particularly Site FR U30) and Atwell Brook on both August 30 (Figure 13) and October 3 indicated elevated particulate debris in the water and there were also clear signs of recent bank undercutting. Bank undercutting upstream of the sampling locations may have at least partially been associated with the increased instream turbidity levels.

Figure 13. Atwell Brook, August 30, 2011

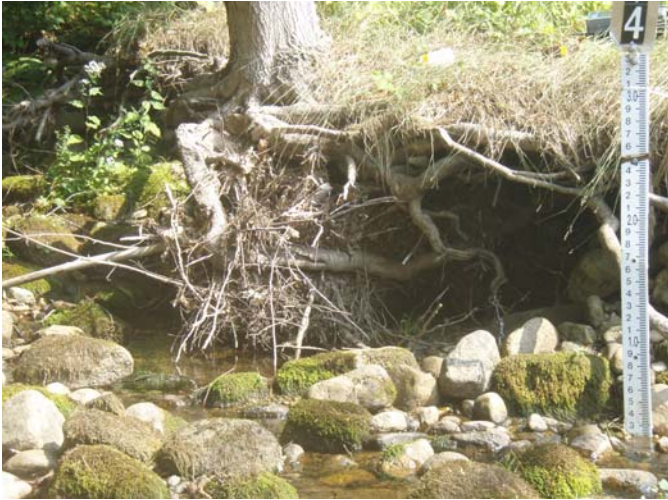
Figure 21. Whittemore Brook bank undercutting
(August 30, 2007)

been removed. Riparian cover not only minimizes the phosphorus and sediment loading into surface waters but it also enhances fishery habitat and provides travel corridors for wildlife species.

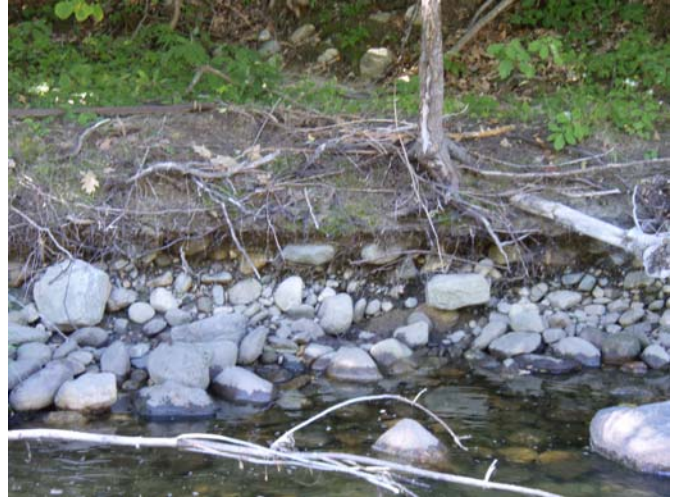
Figure 22. Fowler River (Site 22 Fowler)
bank undercutting (Photographed August 17, 2007)

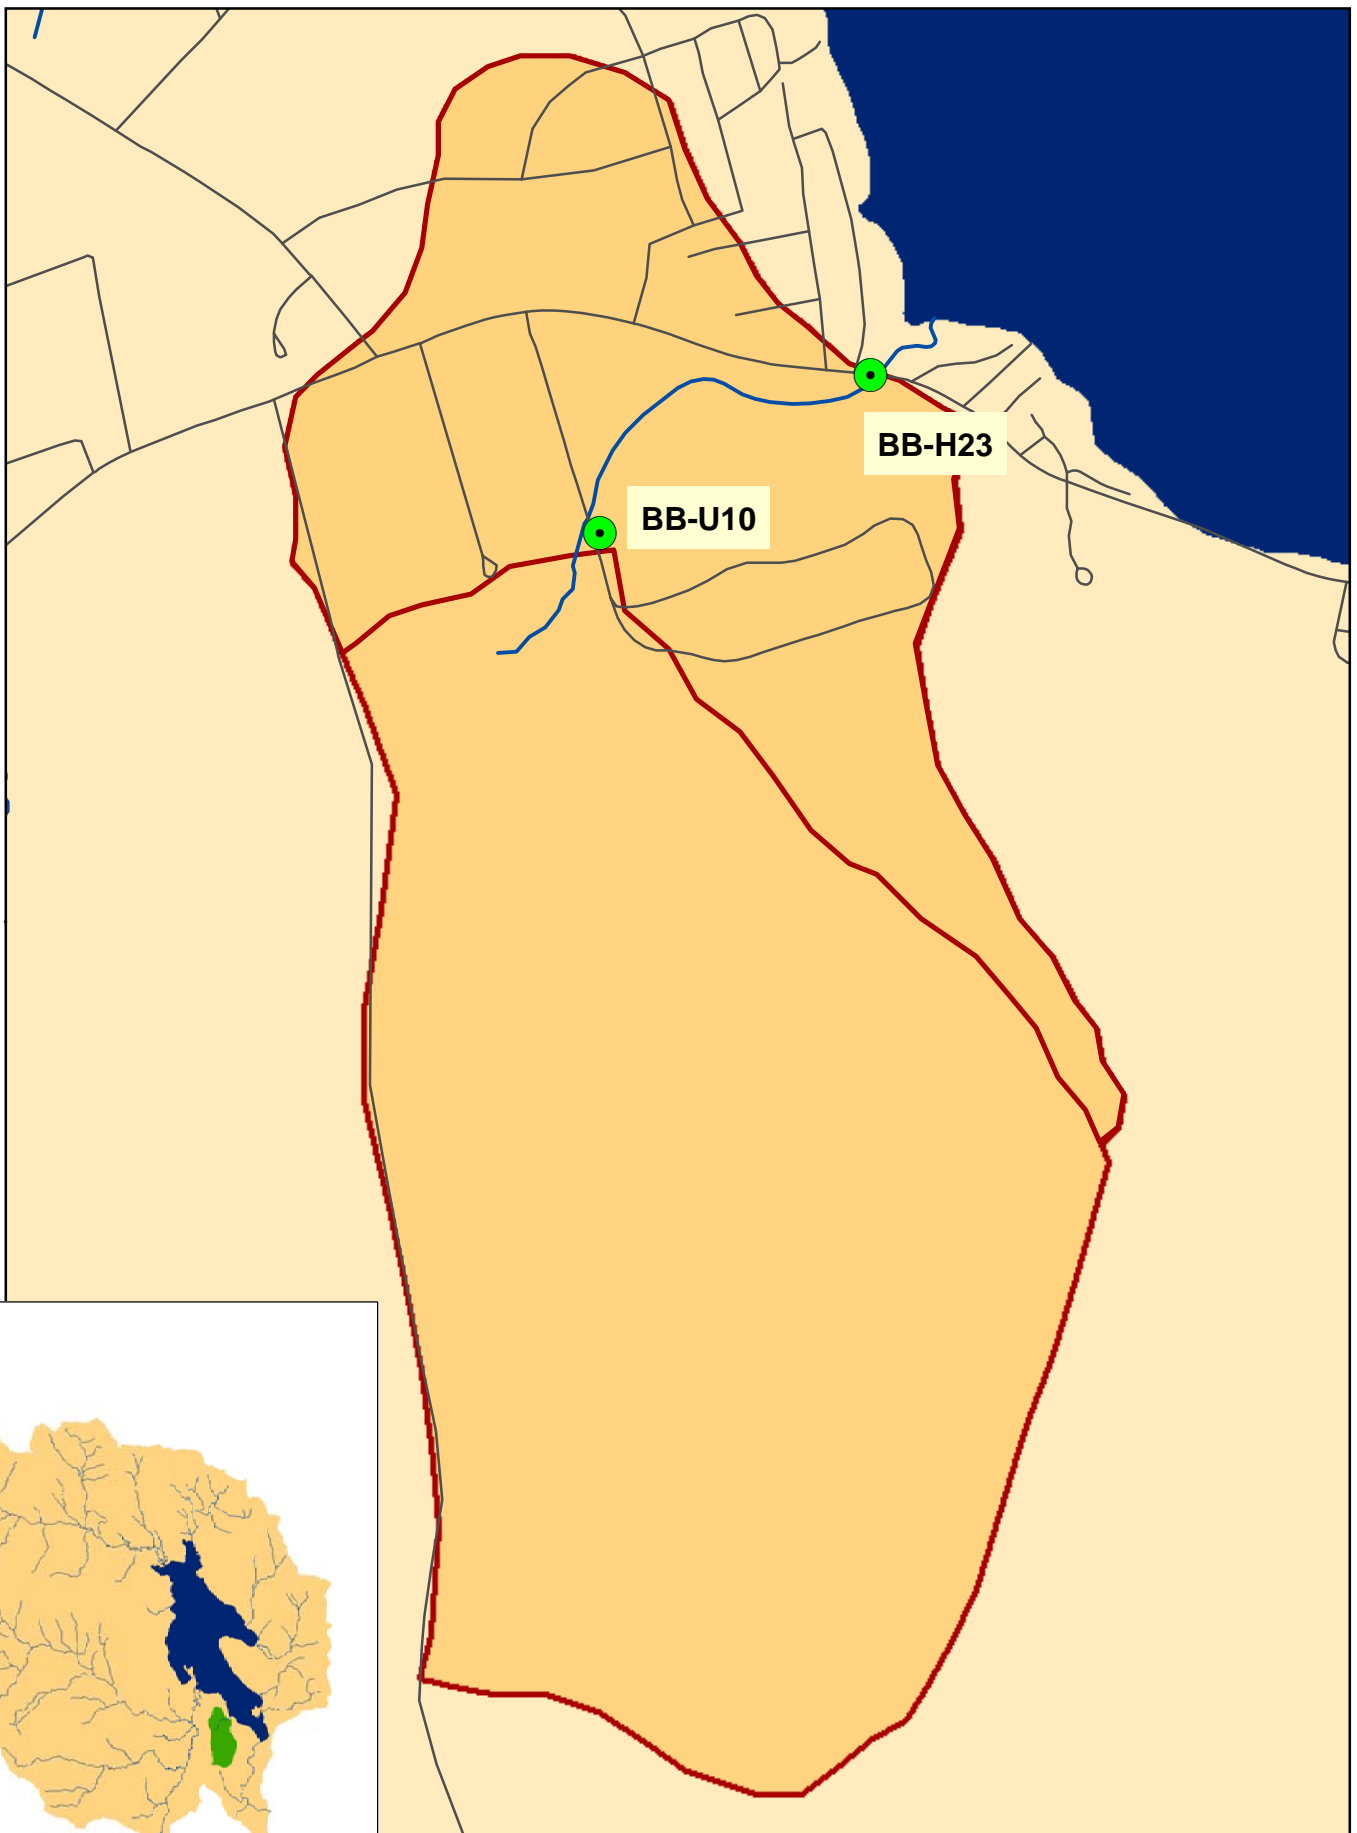
Black Brook Subwatershed

The following subwatershed maps represent active and proposed headwater tributary sampling locations in the Black Brook, Cockermouth River, Dick Brown Brook, Fowler River, Georges Brook, Hemlock Brook, Tilton Brook and Whittemore Brook subwatersheds. Each map includes a vicinity map of the Newfound Lake watershed, which highlights the subwatershed of interest in green. Each map also includes the subwatershed boundary (represented by the red lines), sampling points with site ID information (represented by green points), roads (gray lines), and tributaries (blue lines).

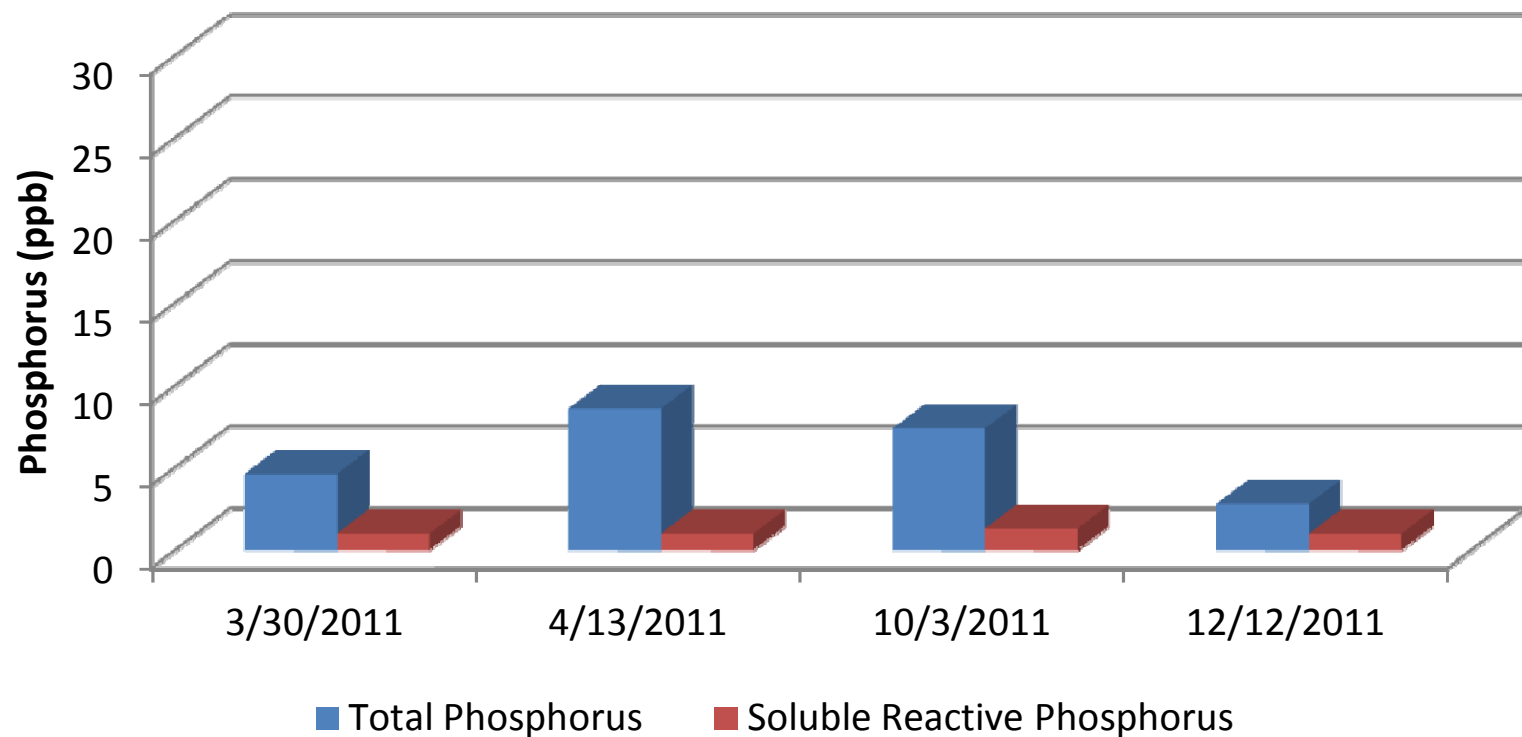
Fowler River Subwatershed - Site U60

Comparison of 2011 Total Phosphorus and Soluble Reactive Phosphorus Results
