Historic Resource Inventory - Bristol United Church of Christ

Lakes Region Planning Commission - Bristol, New Hampshire

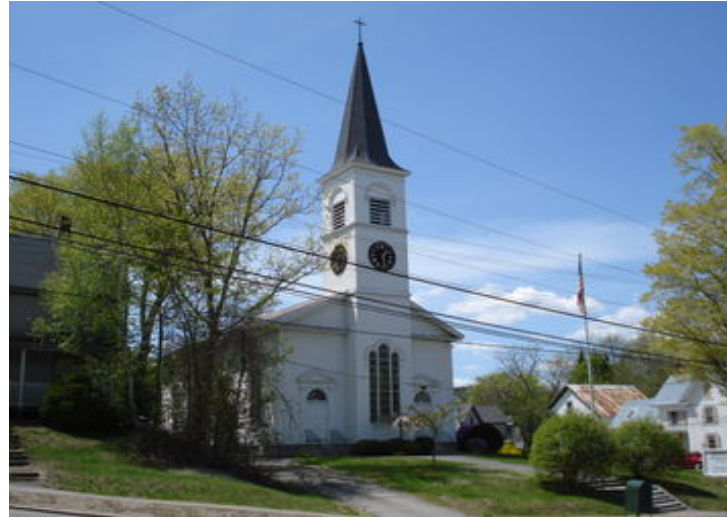
Photo

Original church modeled after Salisbury Meeting House. Enlarged and Victorianized in 1870.
David Ruell
1982
Dorcas Gordon

Building Type	Church
Number of Stories	1.5
Dimensions	44 x 70
Bays	3 x 4
Architecture Form	Rectangular plan
Foundation	Cut granite blocks
Structure Type	Post and beam
Wall Sheathing	East - flushboard; Rest of structure clapboard
Wall Ornamentation	Paneled corner pilasters
Roof Type	Gable
Roof Sheathing	Sheet metal
Dormers/Cupolas	
Roof Details	
Number of Chimneys	3
Chimneys Location	Interior slope
Chimney Materials	Brick
Chimneys Description	Corbeled caps
Gable End Eaves Treatment	Box cornice, deep frieze, pedimented (interrupted by tower)
Windows Placement	symmetrical, paired
Windows Shape	semi-circular arches
Windows Sash	8 over 6
Windows Surrounds	Joined arched wooden hood moulds
Main Entry Location	2 main entry doors - off center — on the East side
Main Entry Door	Double paneled doors
Main Entry Surround: Flanked	
Main Entry Surround: Topped	Semi-circular fanlight
Main Entry Framed	Paneled pilasters supporting pediment with dentiled cornice

Number of Bay Windows/Towers	1
Bay Windows/Towers Location	Center East facade
Bay Windows/Towers Stories	3
Bay Windows/Towers Shape	Square plan
Bay Windows/Towers Description	Story 1 - triple arched window; Story 2 - clock; Story 3 - belfry with arched openings, octagonal spire
Number of Ells/Wings	1
Stories (from map)	2
Bays	Irregular
Ells/Wings Description	Modern addition to rear of church, incorporating classrooms, offices, meeting rooms, etc.
Storefronts Configuration	
Storefronts Windows	
Storefronts Doors	
Storefronts Signage	
Storefronts Materials/Details
