Historic Resource Inventory - Prescott House

Lakes Region Planning Commission - Bristol, New Hampshire

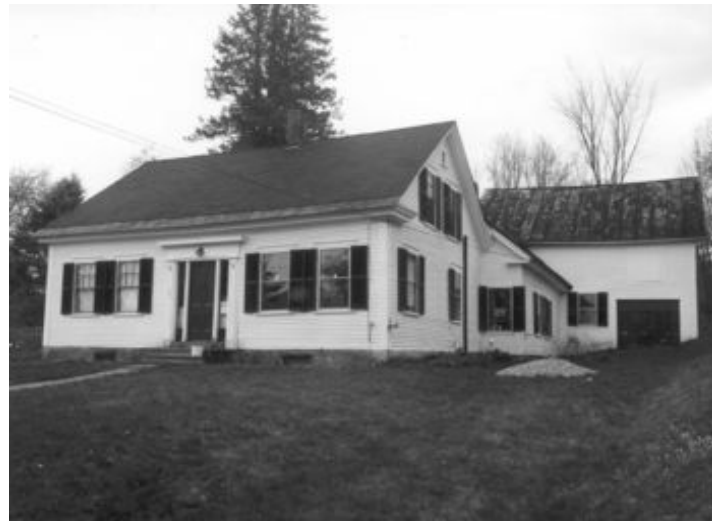
Photo

Vernacular
House
1.5
32 x 26
5 x 2
Cape

Foundation	Cut granite block
Structure Type	Horizontal plank wall
Wall Sheathing	Clapboards
Wall Ornamentation	Corner boards
Roof Type	Gable
Roof Sheathing	Asphalt shingles
Dormers/Cupolas	
Roof Details	
Number of Chimneys	1
Chimneys Location	Center ridge
Chimney Materials	Brick
Chimneys Description	Plain and narrow
Gable End Eaves Treatment	Box cornice with narrow frieze, short returns
Windows Placement	Symmetrical
Windows Shape	Rectangular
Windows Sash	1-Jun
Windows Surrounds	Lintel with simple moulding, louvered shutters
Main Entry Location	Center N facade
Main Entry Door	4 panel
Main Entry Surround: Flanked	Full sidelights
Main Entry Surround: Topped	Entablature w/deep frieze
Main Entry Framed	Paneled pilasters
Number of other entries	
Location of other entries	
Surrounds of other entries	
Number of Porches/Hoods	
Style/Roof Type	
Location of Porches/Hoods	
Porches/Hoods Supports	
Porches/Hoods: Other Features	
Number of Bay Windows/Towers

Number of Ells/Wings	2
Stories (from map)	A - 1
Bays	A - 1 x 2
Ells/Wings Description	A- gabled roof ell, central chimney: B-connected barn with gable roof both clapboard
Storefronts Configuration	
Storefronts Windows	
Storefronts Doors	
Storefronts Signage	
Storefronts Materials/Details
